Soil Stabilization Technology for Road Construction in High Rainfall Areas USA & International Experience

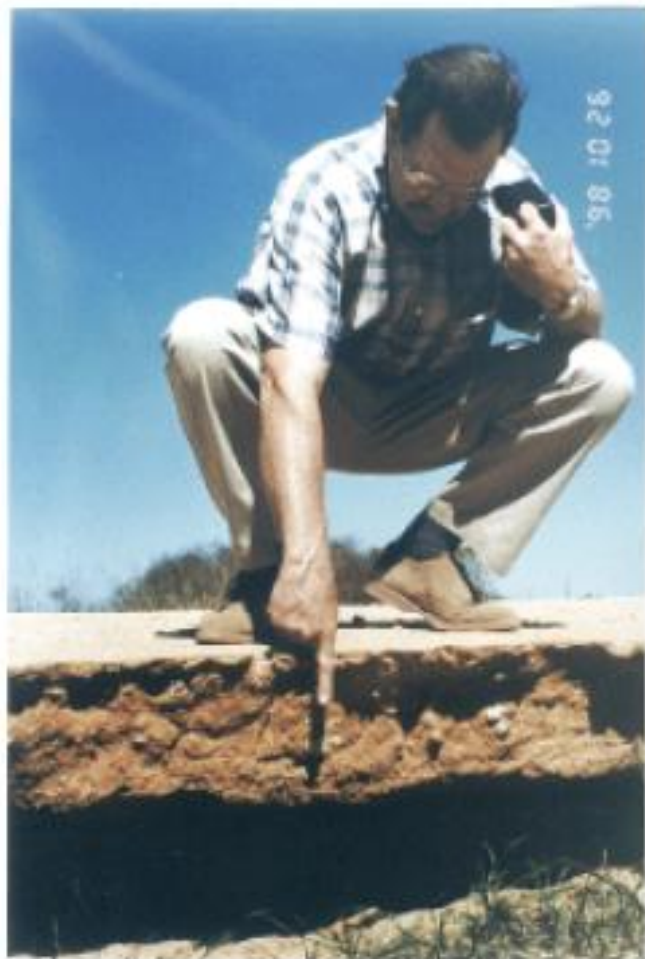
Road which remained solid after 23" flood waters from Hurricane George washed out two feet of earth from under the BASE-SEAL BS-100 and lime stabilized base.

TOP-SHIELD TS-100 was used to seal the surface of this road. It remained smooth and un-damaged, and ready for asphalt surfacing, which was later applied.

Walton County Florida, when Hurricane George slammed into the panhandle coast. On September 27, 1998, the Hurricane hit and made its way through the county, bringing 27 inches (686 mm) of rainfall in a 36 hour period. The flood waters washed out several roads and caused major damage

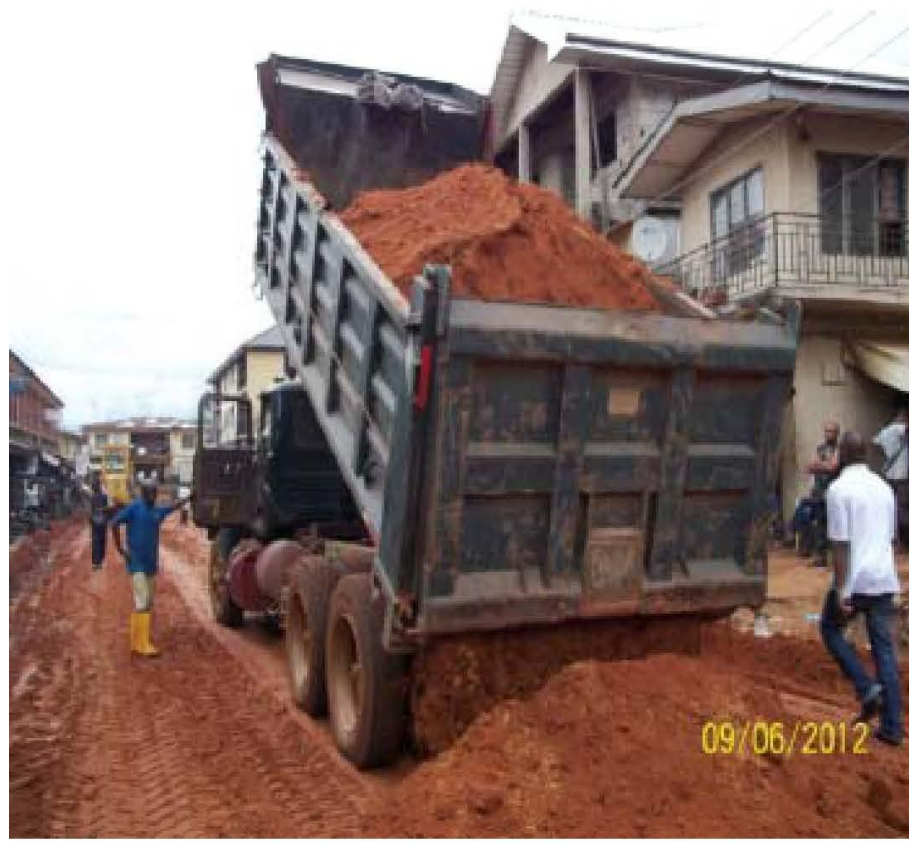
Additional borrow material to elevate road for drainage

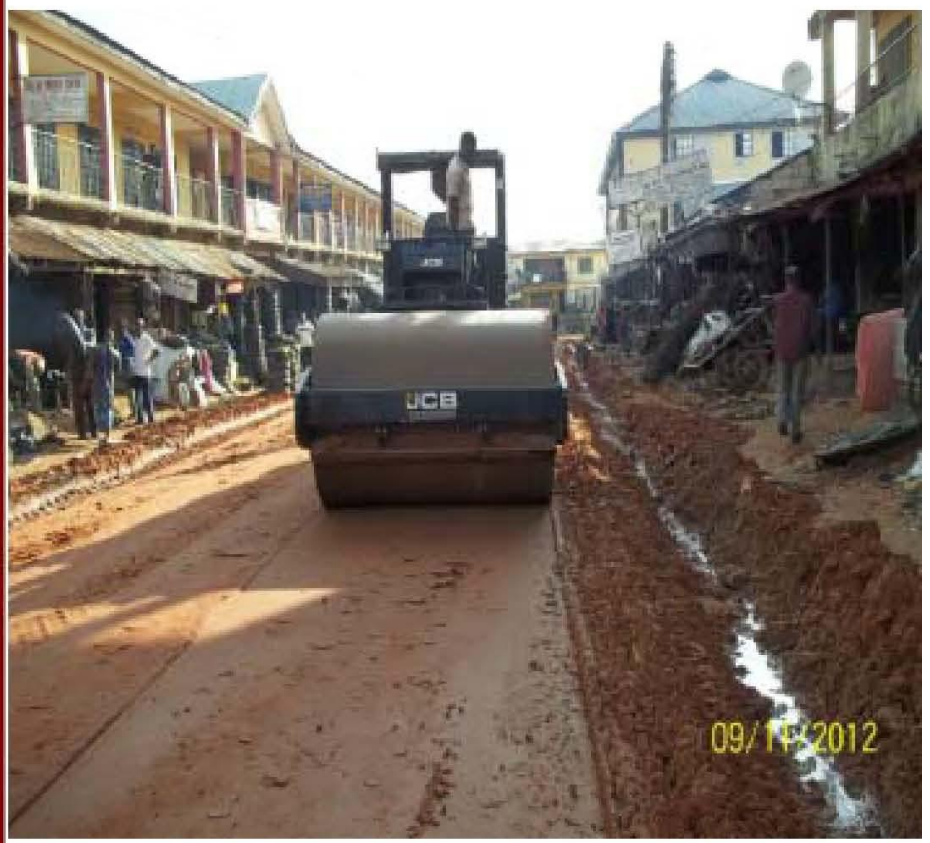
Finishing with a vibratory steel-wheeled roller

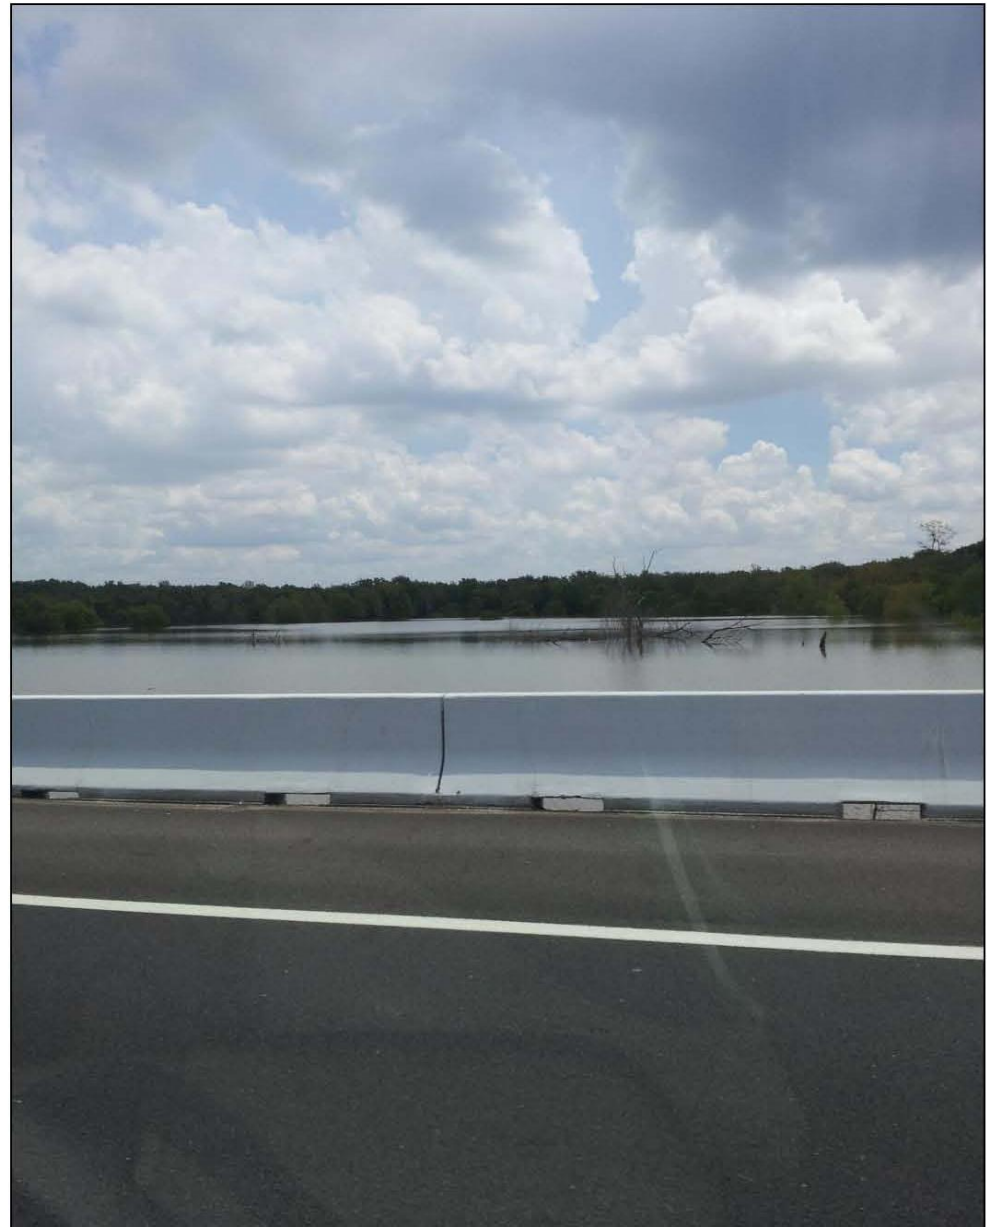
21 years and going on, no maintenance
made ever

Harris County Precinct Three park receives the extra flood waters from the City of Houston that rain brings every season. Some areas stay flooded between two and five months in rainy years.

In the late 1990's roads and civic parking lots of Bear Creek Park were assigned to Base-Seal International to test their products.

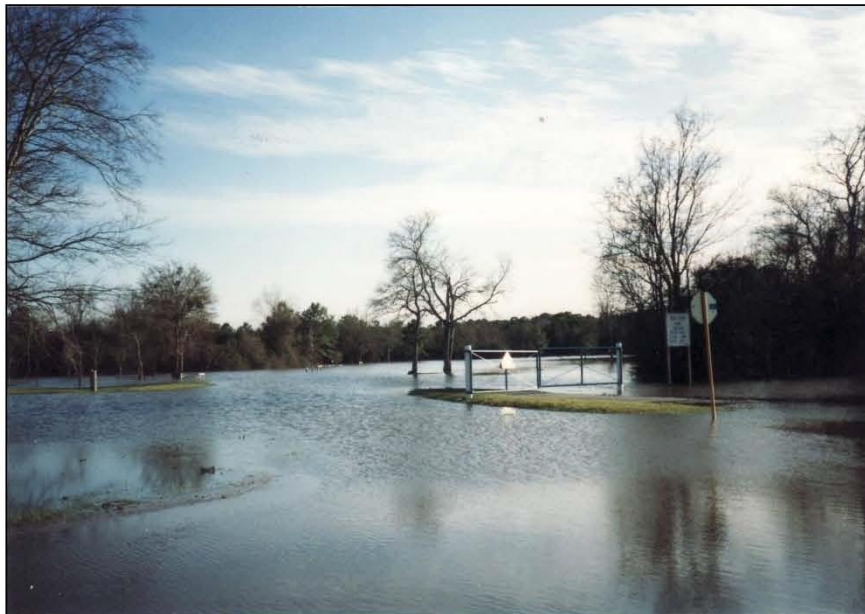
First flood, December 1991

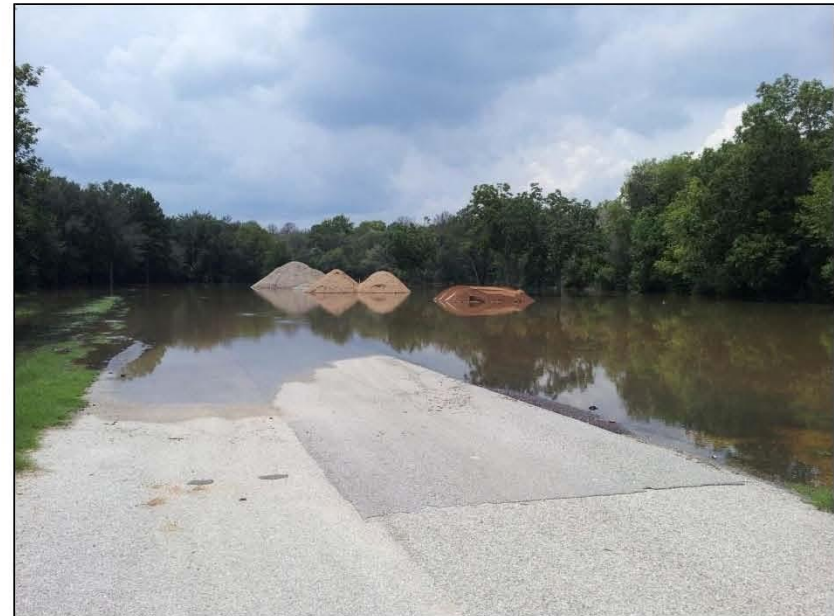
Latest flood July 2012

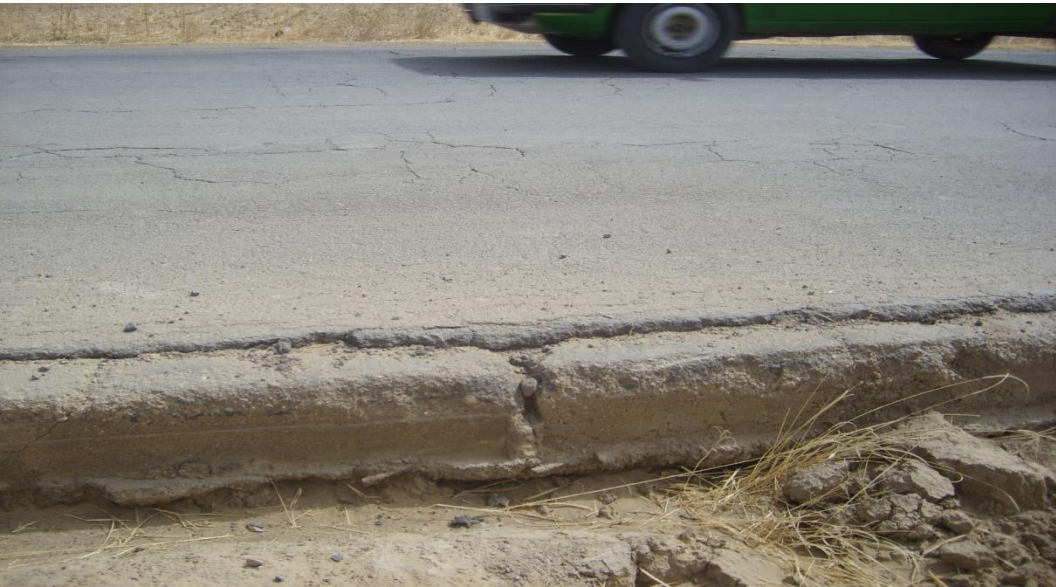
A Section of the Maiduguri-Dikwa-Gamboru Road in Borno State, Nigeria which was stabilized with Base-Seal in 2001. The shoulder was not stabilized and as a result was washed away.

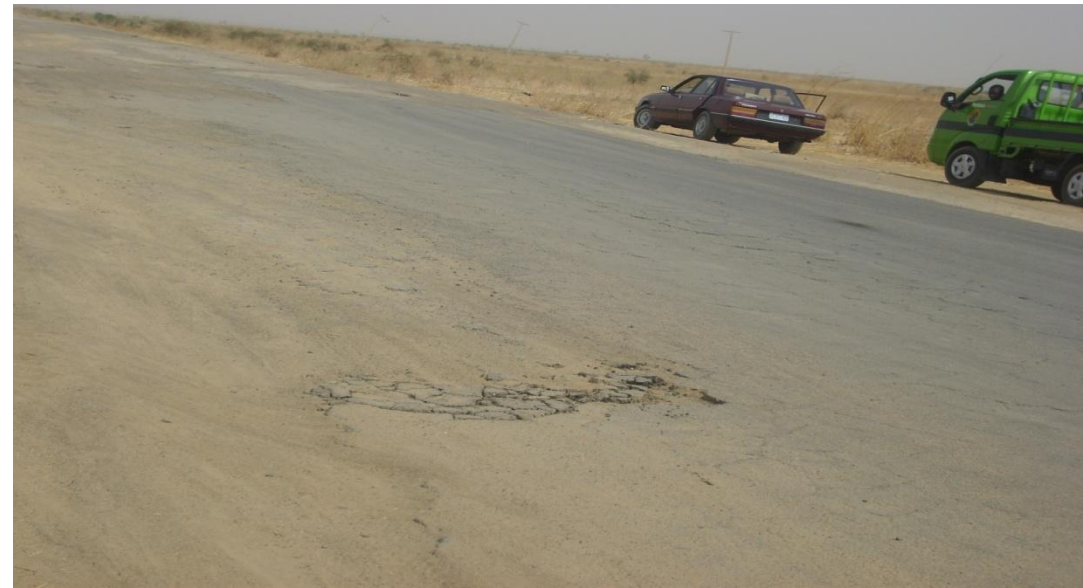
A Section NOT stabilized

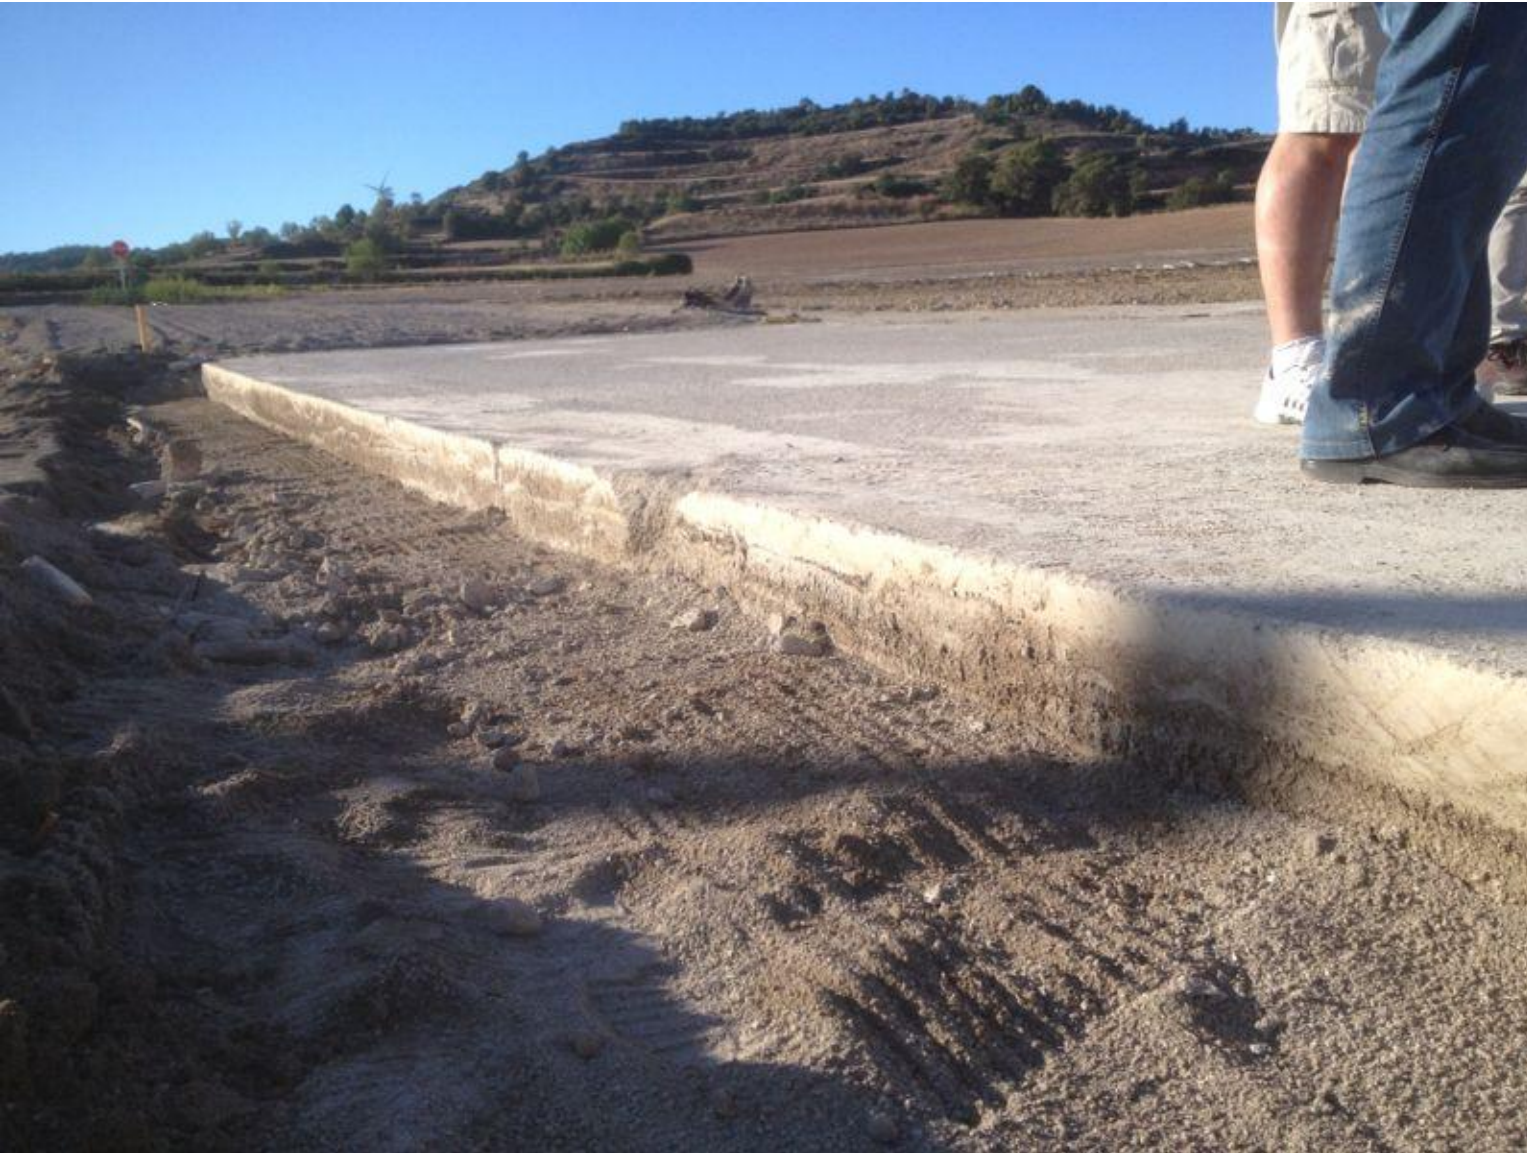
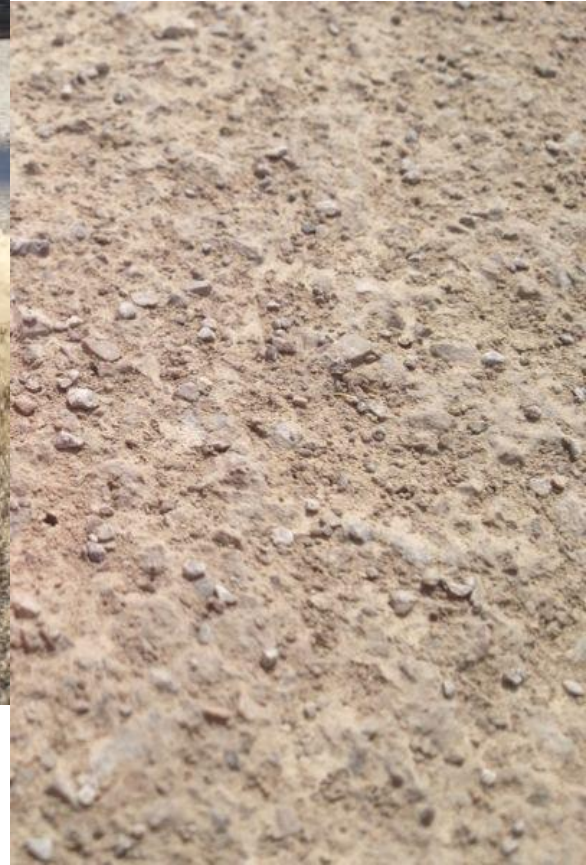
Binding of River Sand

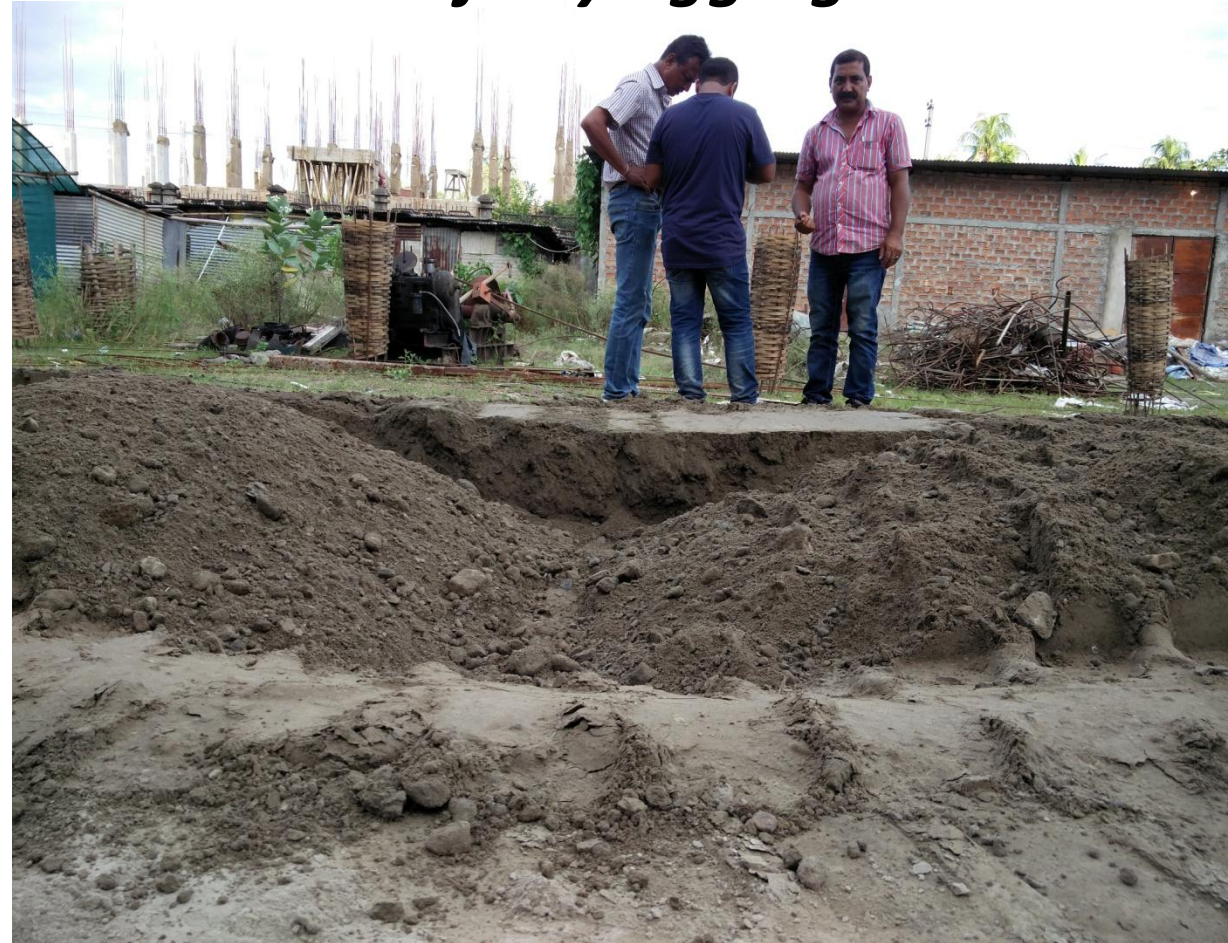
***Processing with Base-Seal
No use of any aggregates***

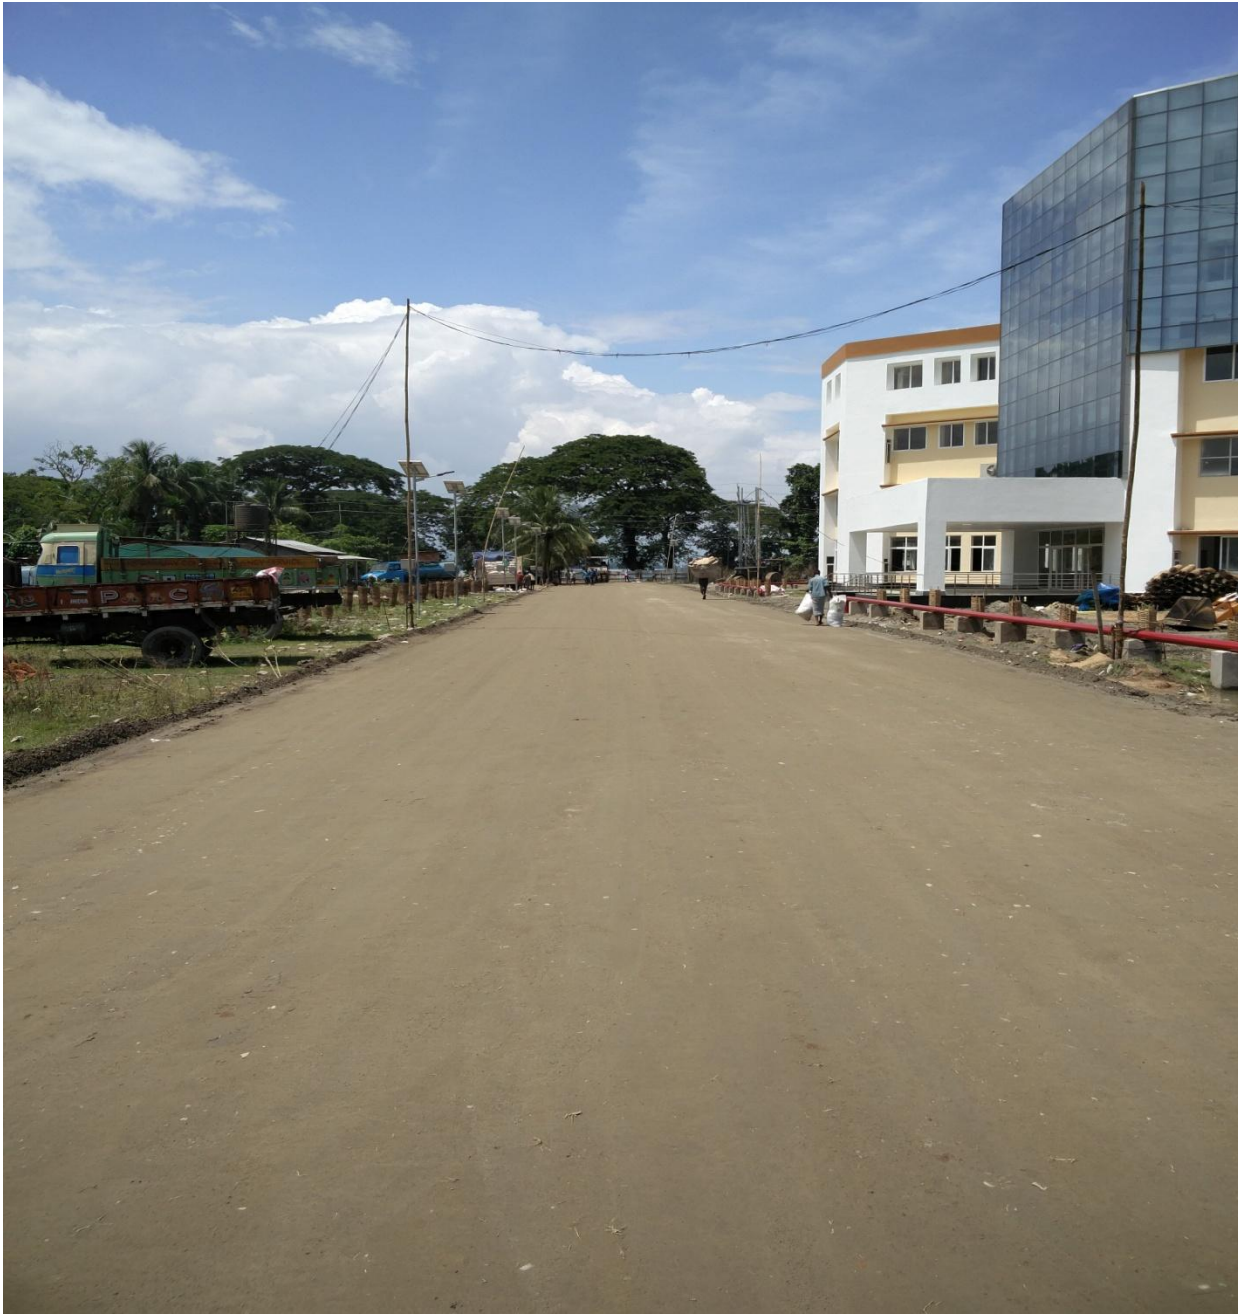
As on 15th July 2016

***Base ready with
Base-Seal for wearing
course application***

***Withstood heavy
rains on 14th July
2016 afternoon***

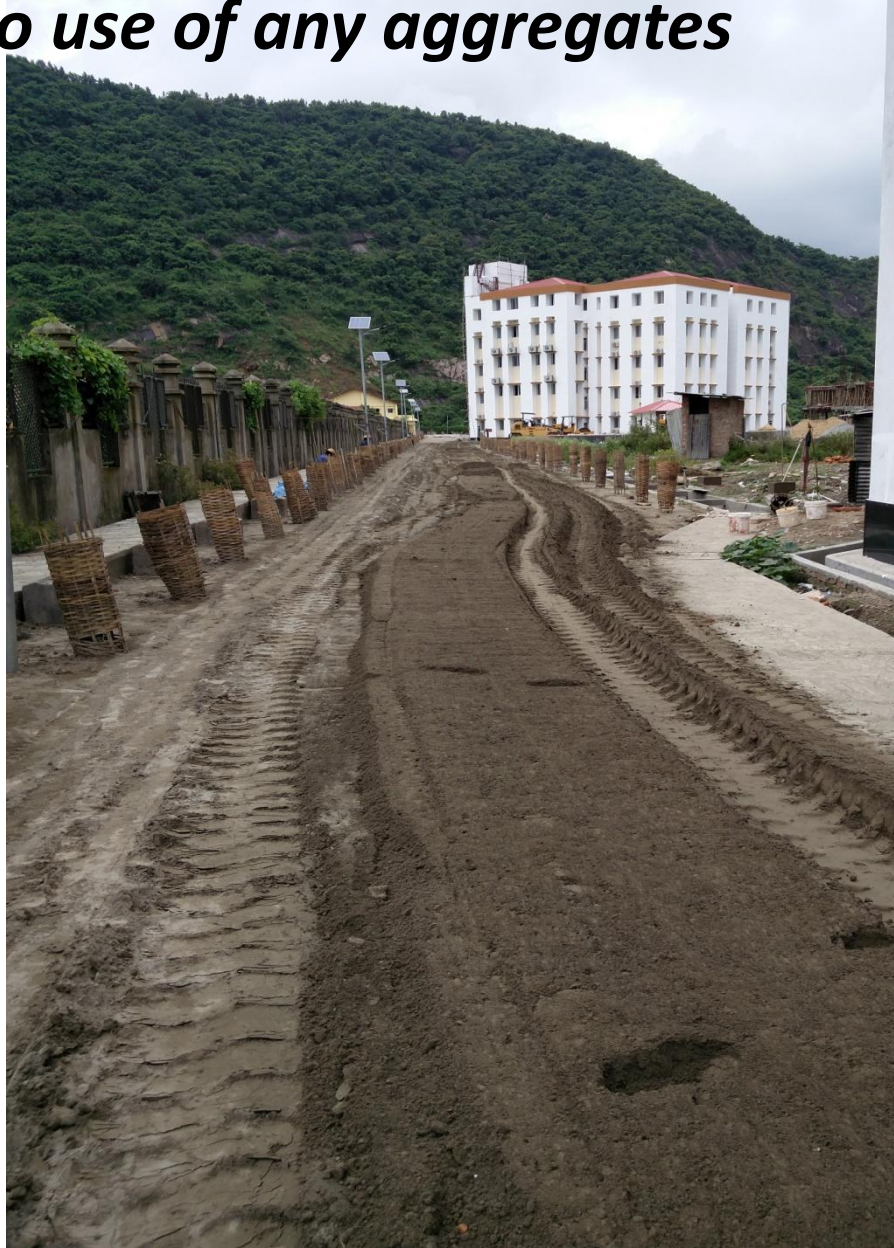
Assam India – Heavy Rainfall Area
Processing with Base-Seal 16th July 2016 morning
No use of any aggregates

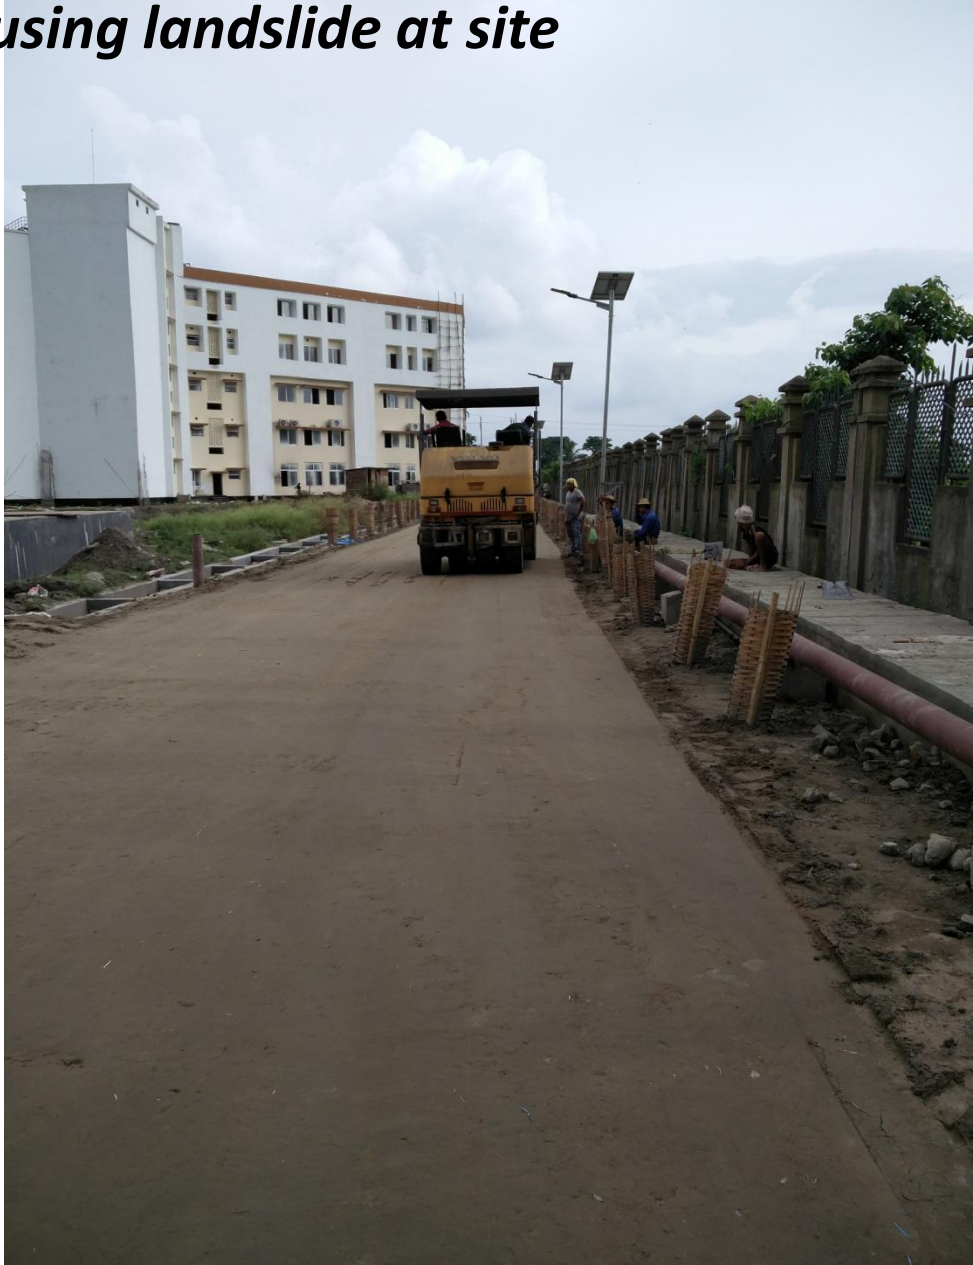
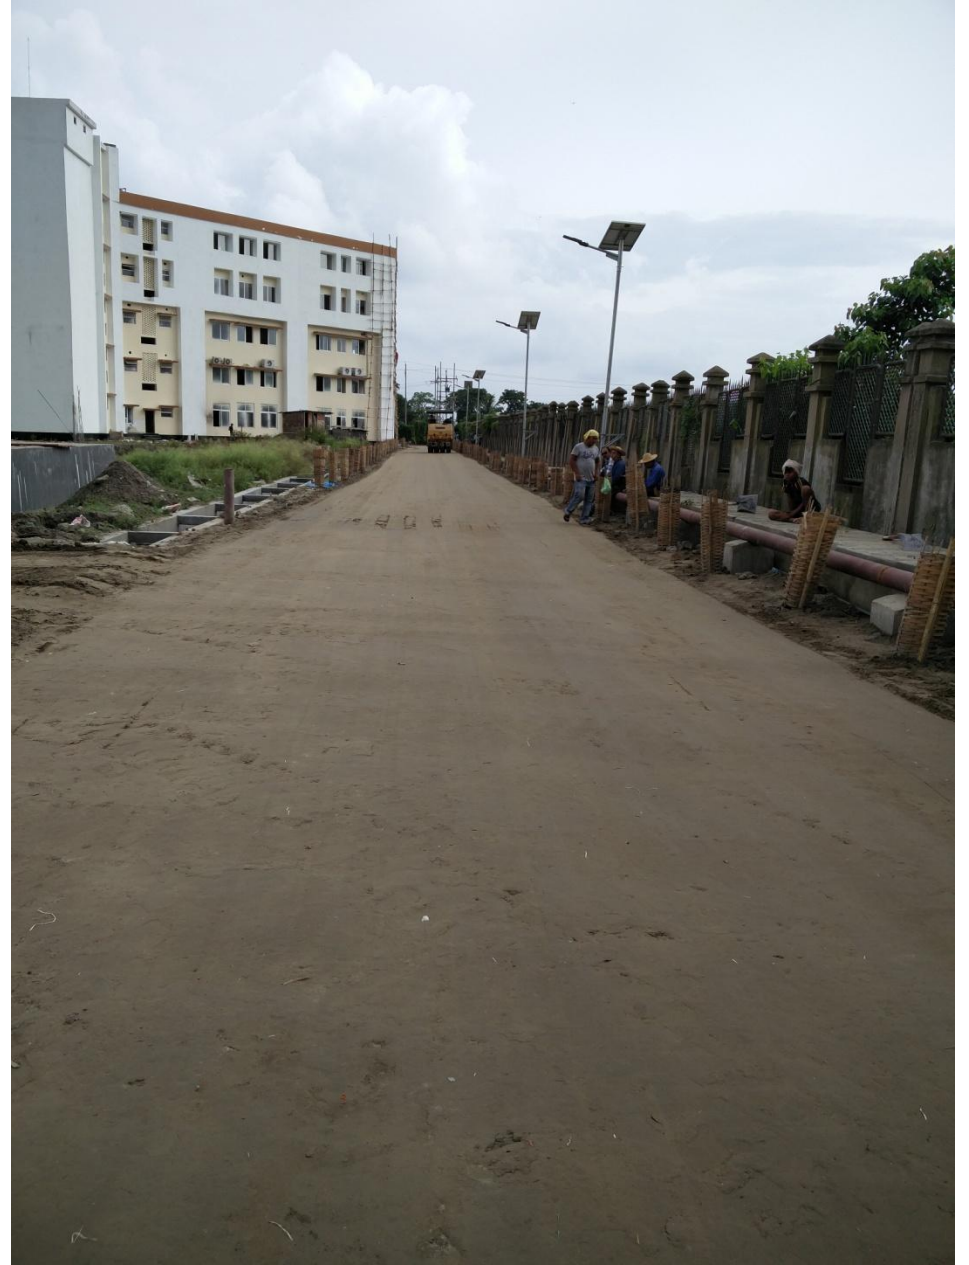
Base ready with Base-Seal 16th July 2016 4:00 PM
Withstood heavy rains on 16th July 2016 7:00 PM
causing landslide at site

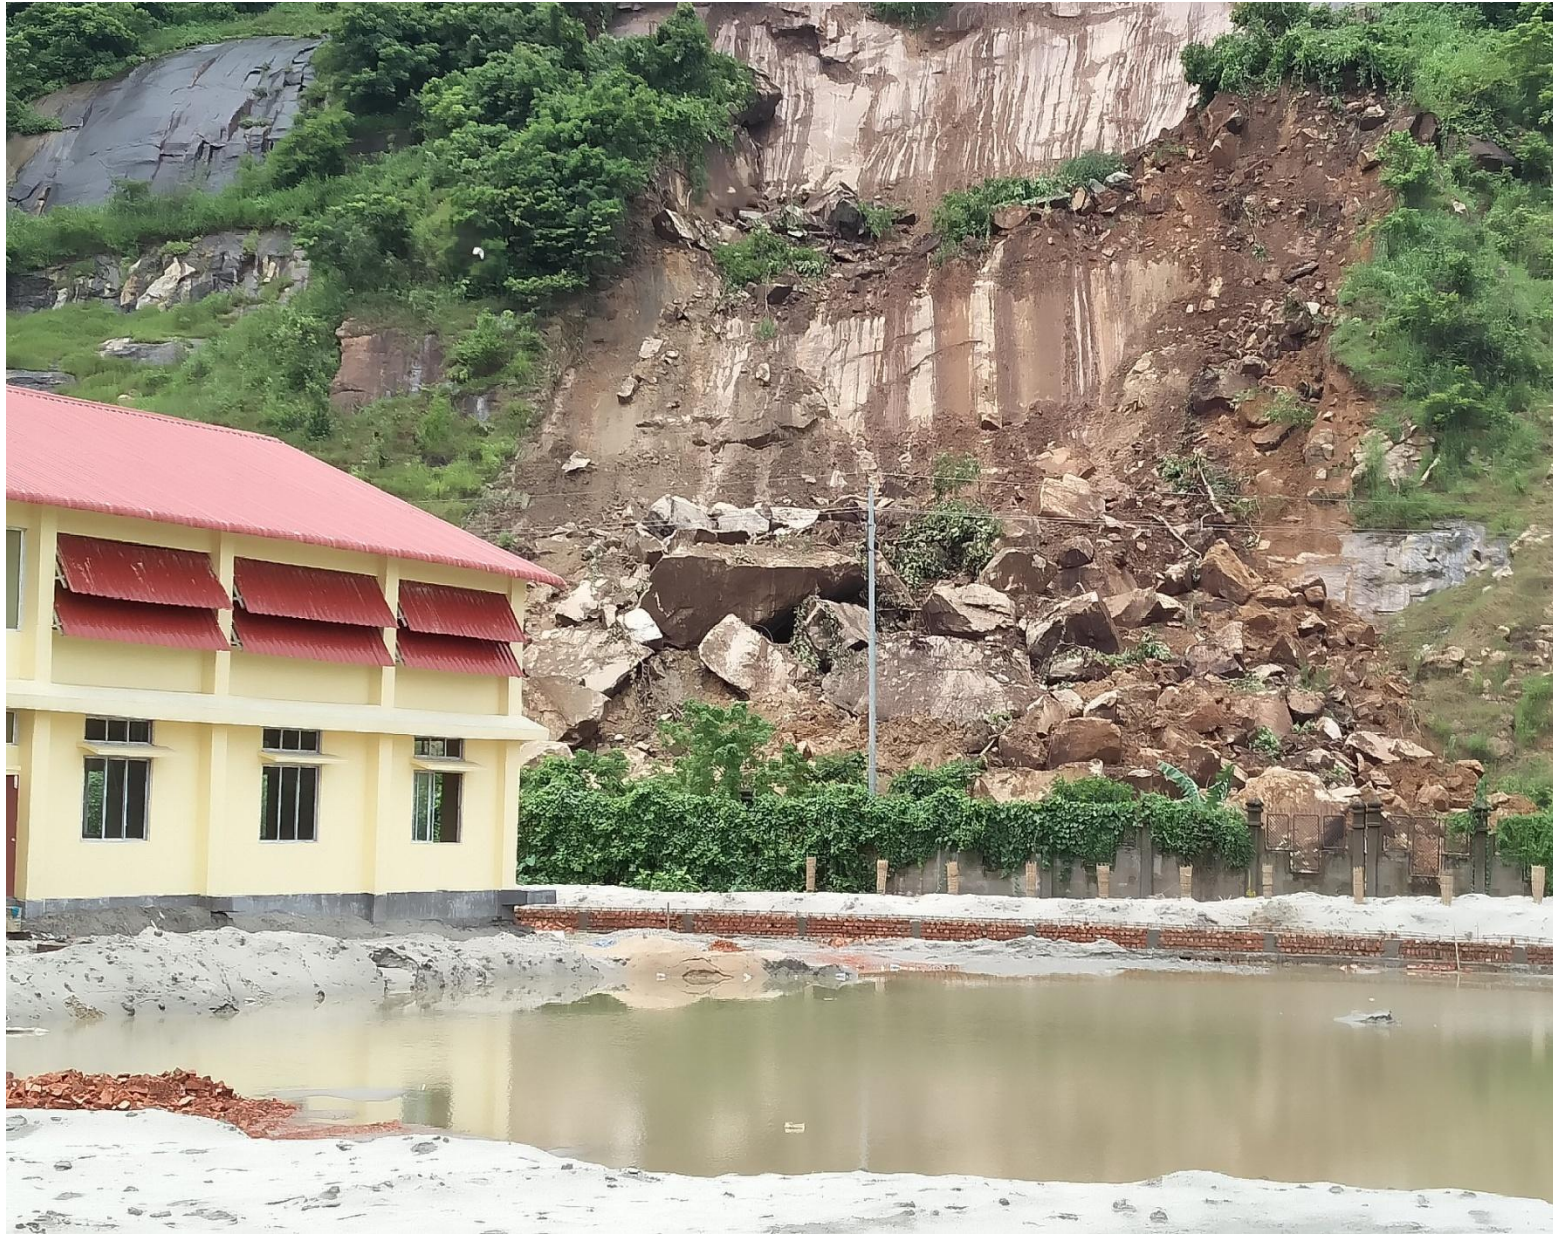
16th July 2016 7:00 PM onwards heavy rains causing landslide at site on 17th July 2016

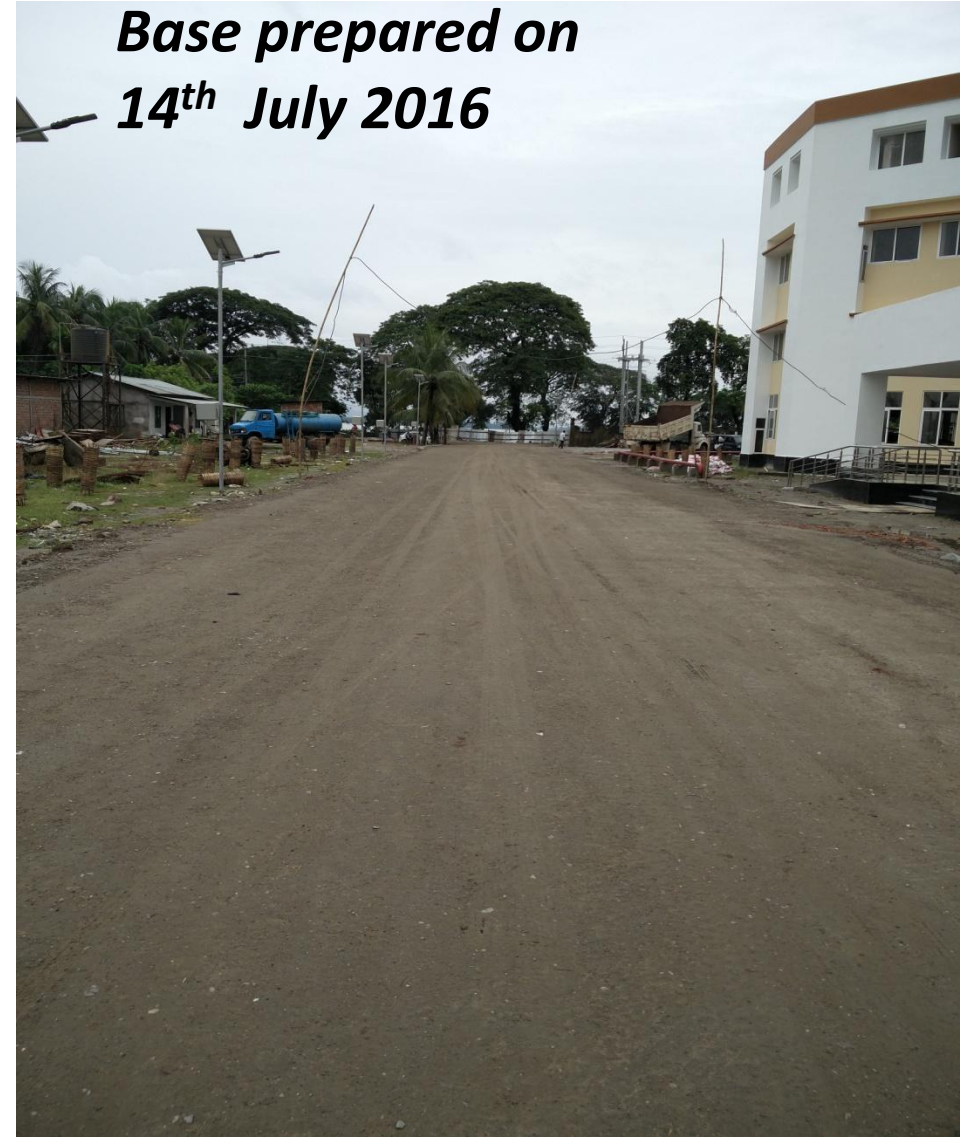
No impact on Base-Seal Base prepared on 14th July 2016
